# **ELECTRODEPOSITION OF WEAR RESISTANT COATINGS**

**April 1990**

**Final Report**

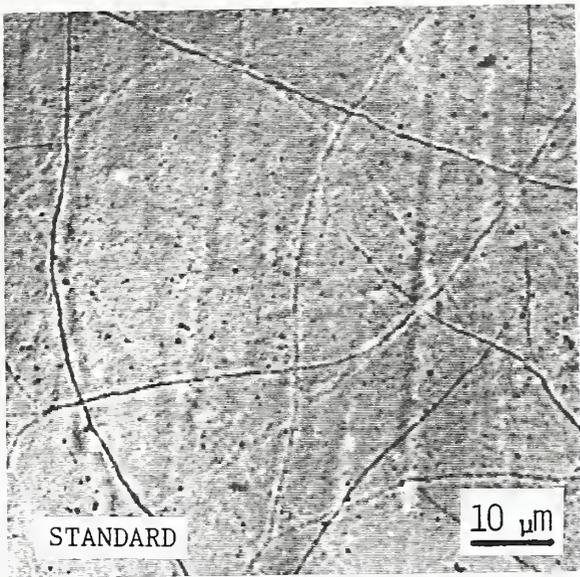
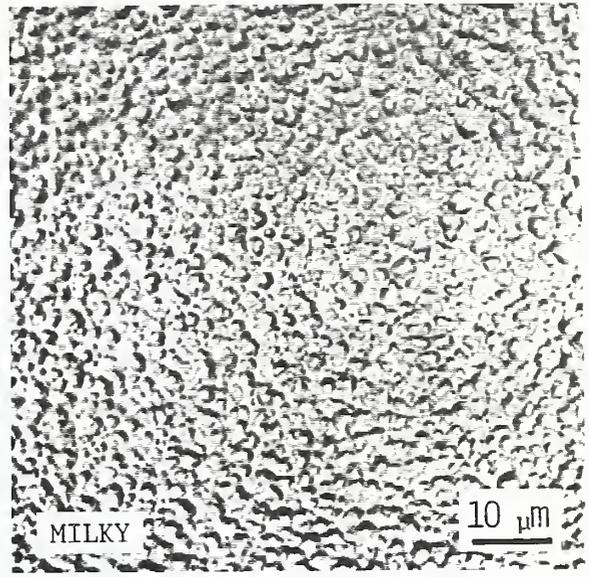
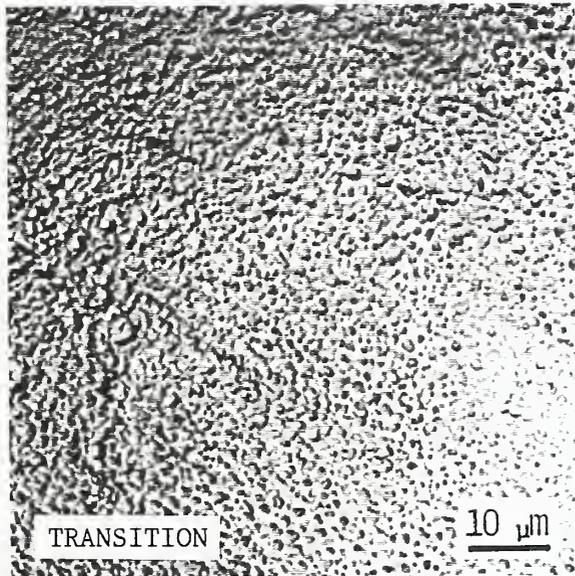
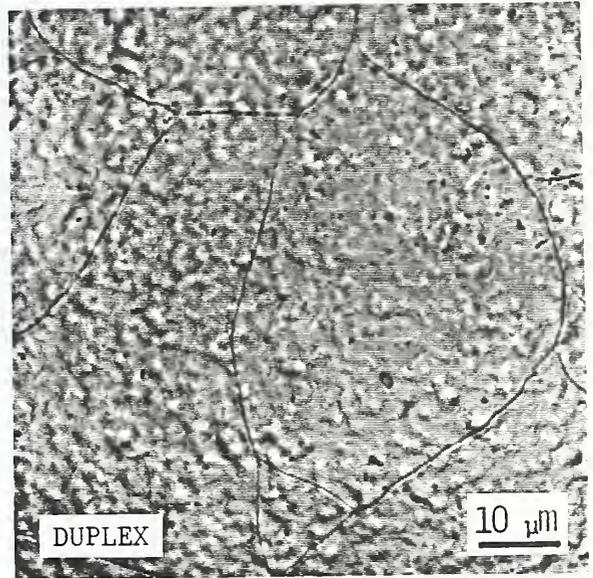
Figure 22. Optical micrographs of surface texture and micro-cracking of various chromium coatings. (a) Standard BEP chromium - 50°C, 25 A/dm<sup>2</sup>; (b) "Milky" chromium - 70°C, 30 A/dm<sup>2</sup>; (c) "Transition" chromium - 70°C, 65 A/dm<sup>2</sup>; (d) Duplex chromium - 70°C, 30 A/dm<sup>2</sup> and 50°C, 25 A/dm<sup>2</sup>.

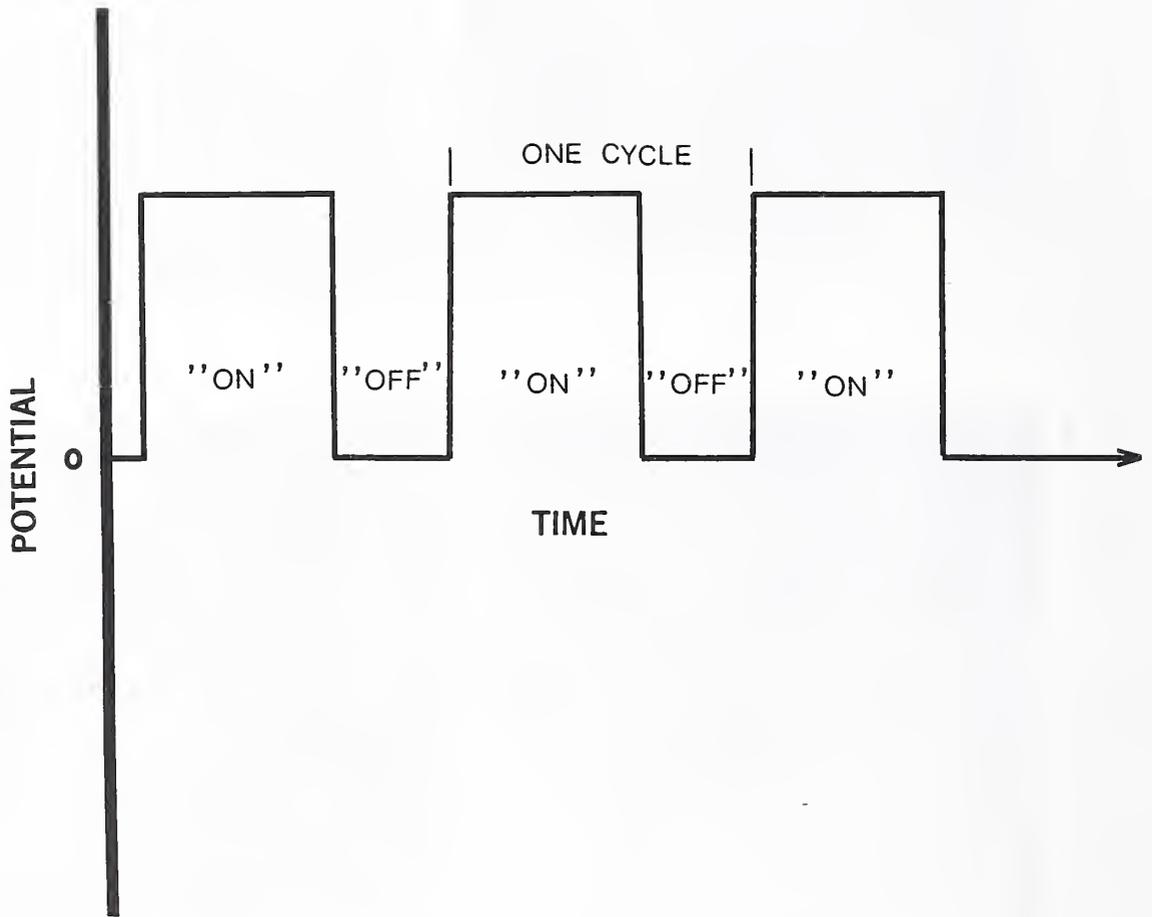
Figure 23. Potential - Time waveform for pulse plating of chromium.

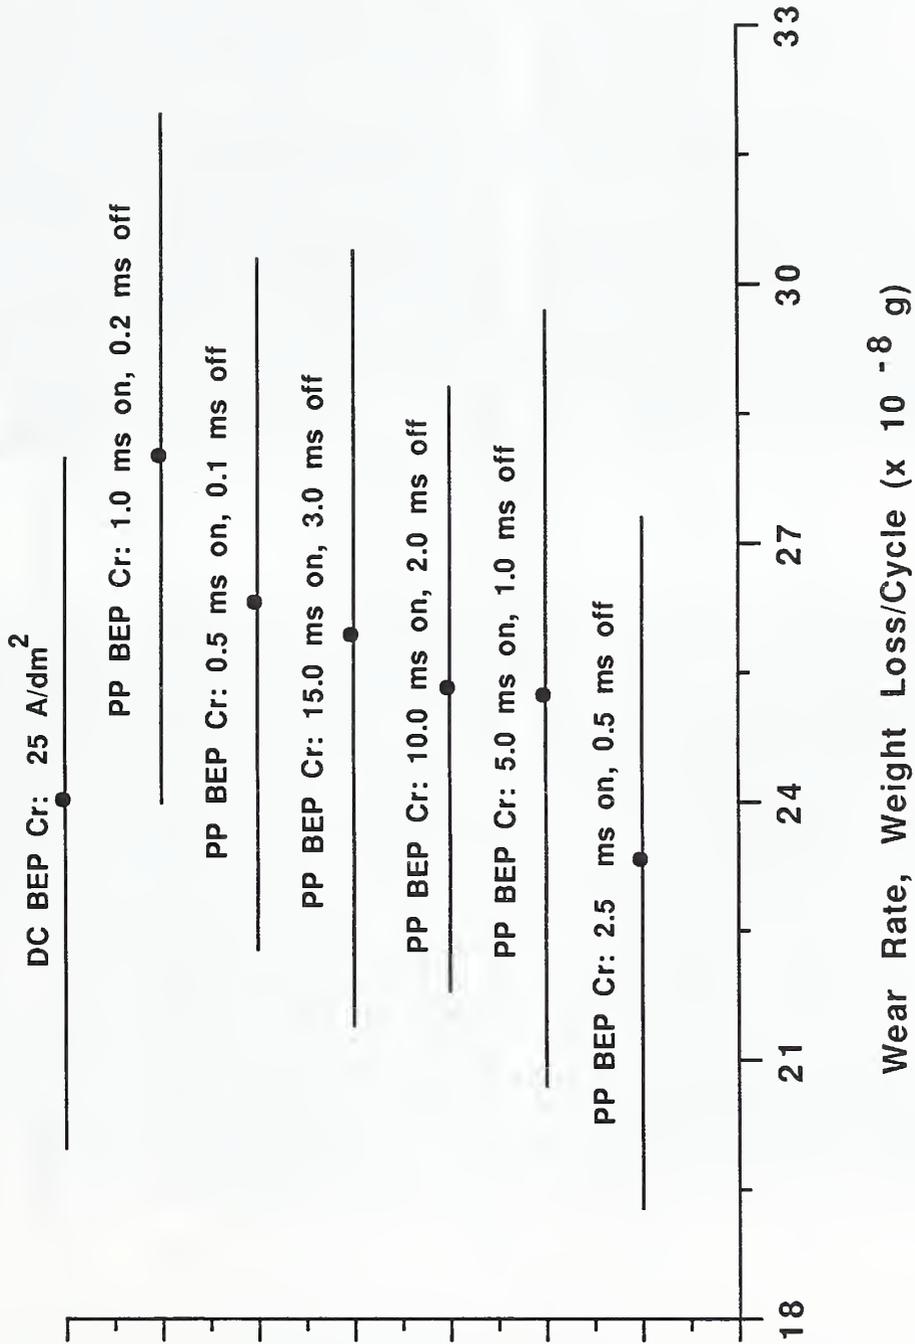
Figure 24. Wear rate determined by the abrasive slurry tester at a load of 1500 g-f for a test duration of 150 cycles of pulse plated chromium coatings at various on/off times compared to the DC BEP chromium. Results are averages of five tests plus and minus one standard deviation.

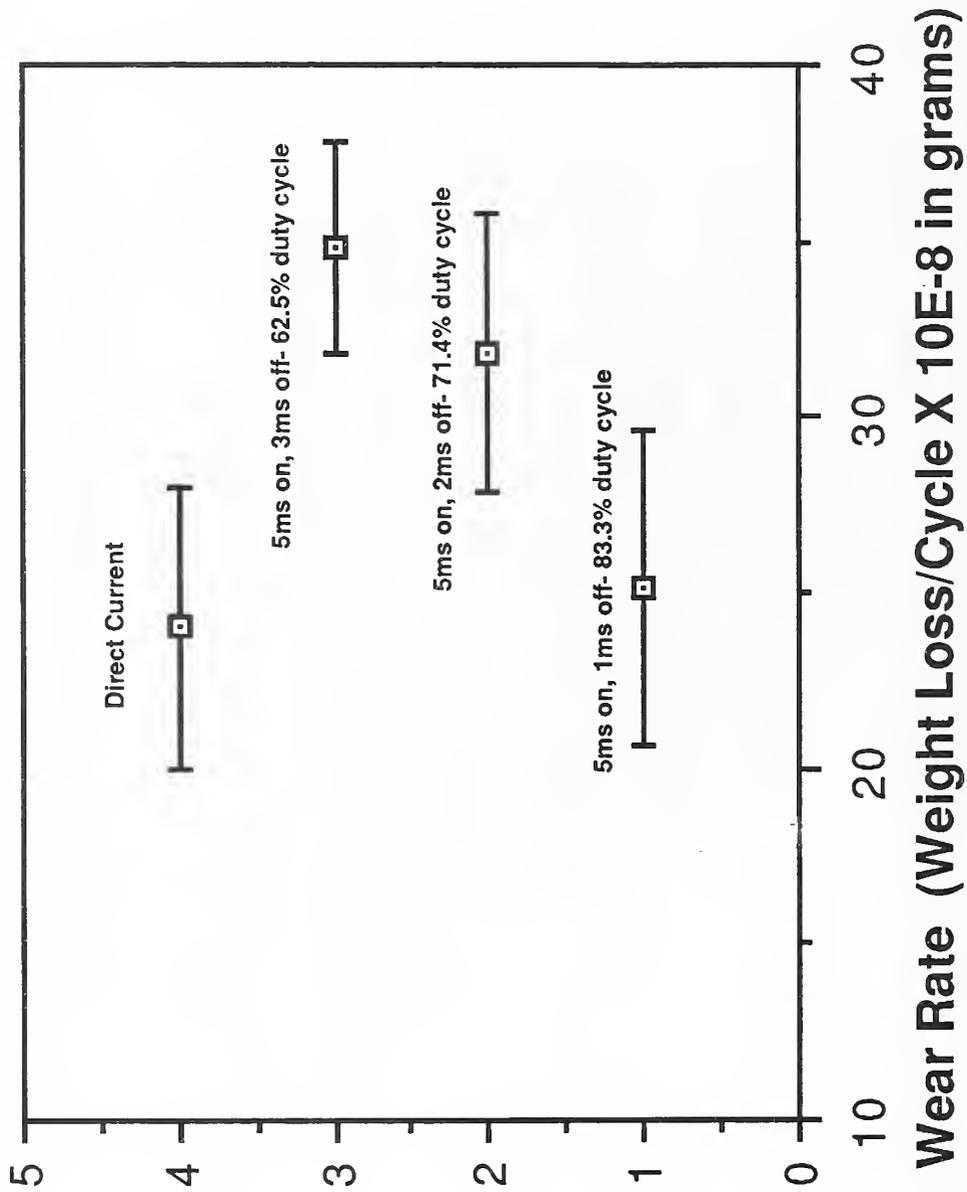
Figure 25. Wear rate determined by the abrasive slurry tester at a lead of 1500 g-f for a test duration of 150 cycles of pulse plated chromium coatings at various duty cycles at a temperature of 50°C and average current density of 25 A/dm<sup>2</sup> compared to the DC BEP chromium deposited at 50°C and 25 A/dm<sup>2</sup>.

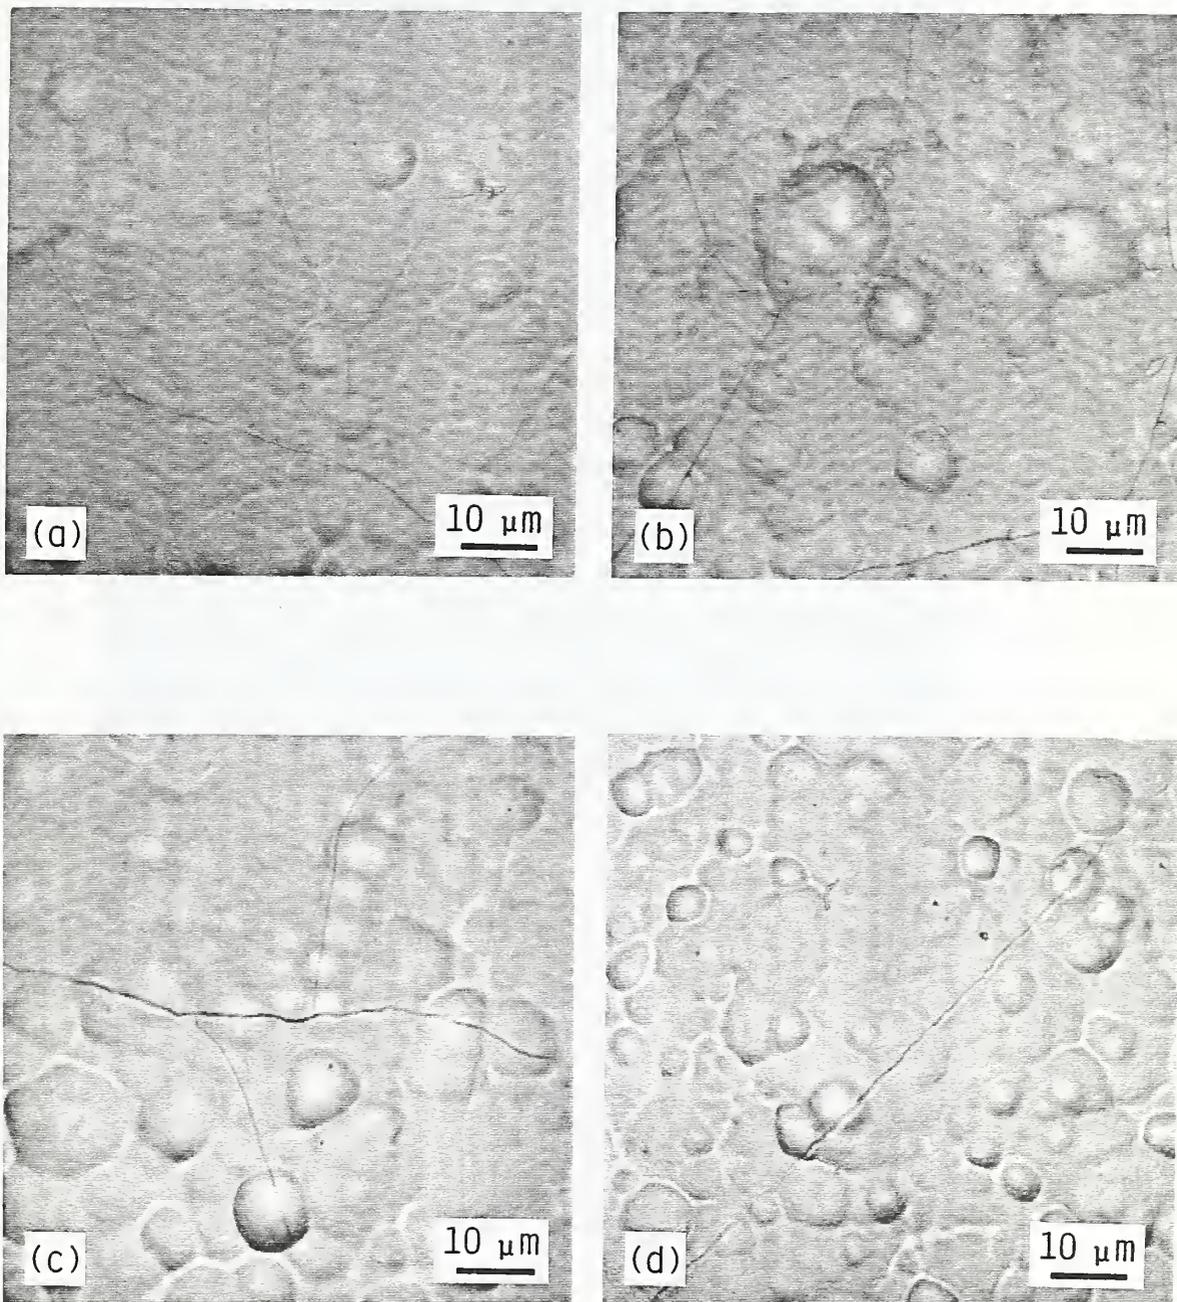
Figure 26. Optical micrographs of the surface texture and crack density of pulse plated chromium coatings for various on/off times at a duty cycle of 83.3% in the BEP chromium electrolyte at 50°C and average current density at 25 A/dm<sup>2</sup>. (a) 0.5 ms on/0.1 ms off; (b) 1.0 ms on/0.2 ms off; (c) 2.5 ms on/0.5 ms off; (d) 5.0 ms on/1.0 ms off.

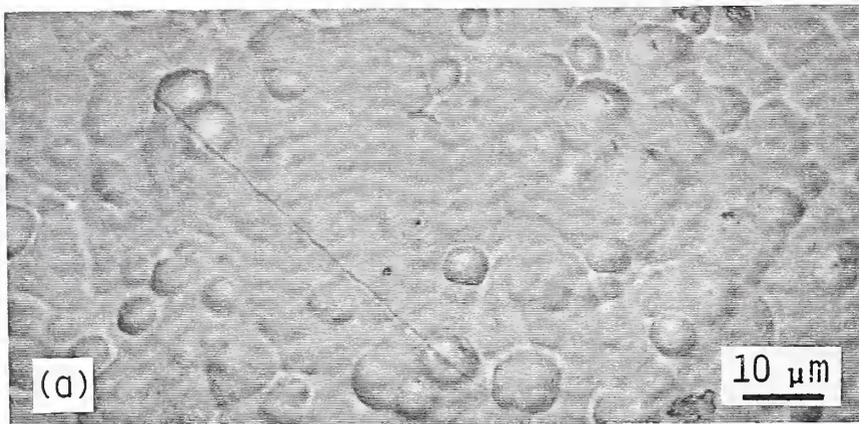
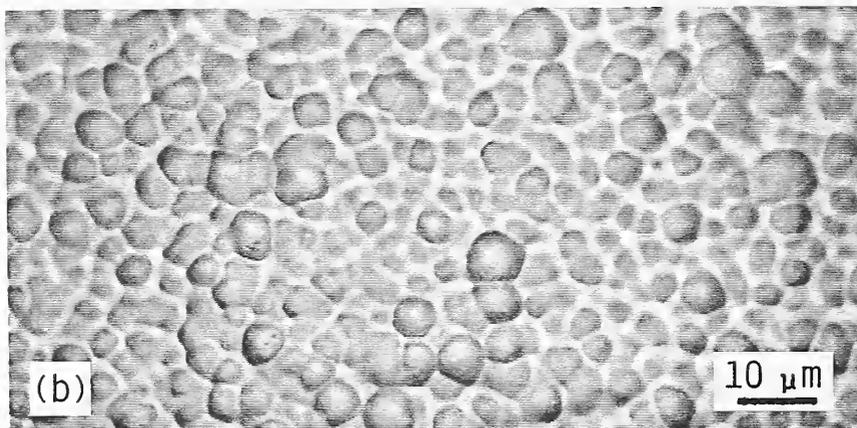
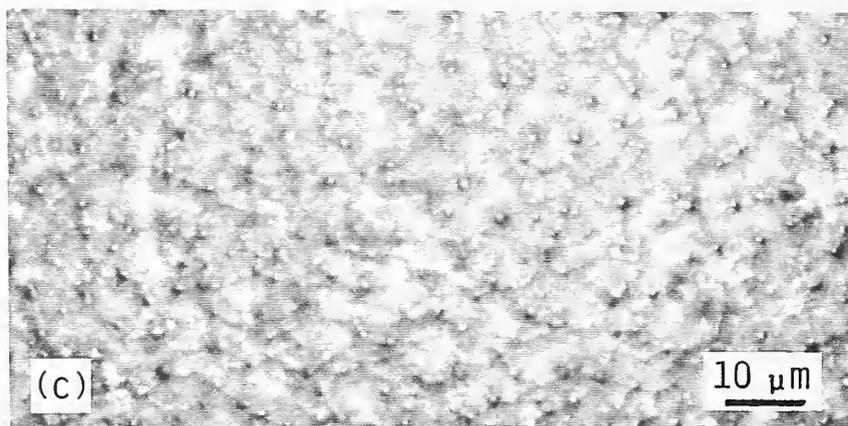
Figure 27. Optical micrographs of the surface texture and crack density of pulse plated chromium coatings for various duty cycles of the same on time of 5ms in the BEP<sub>2</sub> chromium electrolyte at 50°C and average current density of 25A/dm<sup>2</sup>. (a) 83.3%; (b) 71.4%; (c) 62.5%.

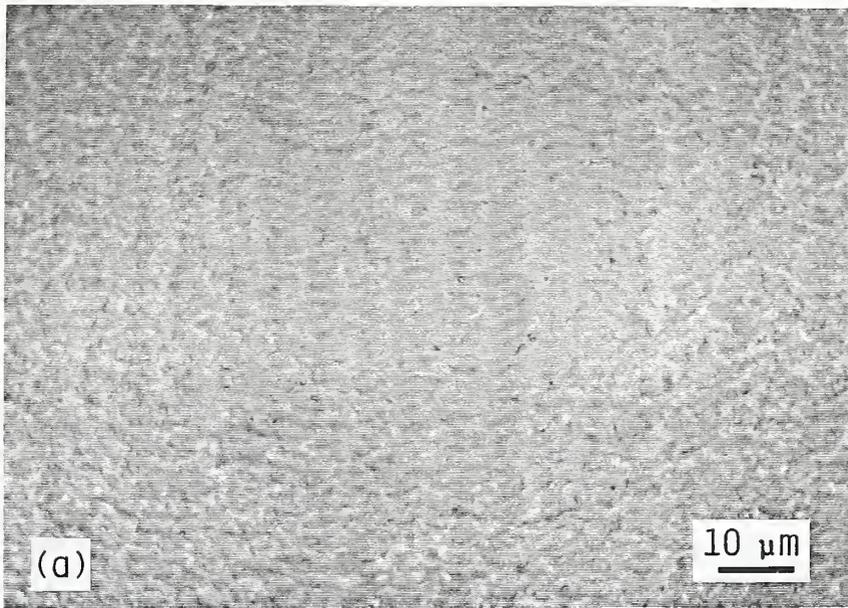
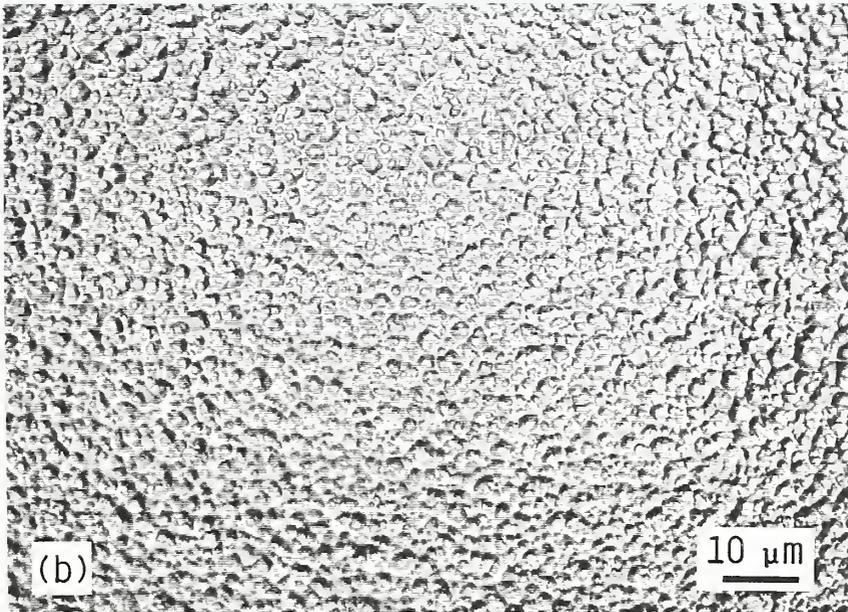
Figure 28. Optical micrographs of the surface texture and crack density of (a) pulse plated semibright chromium coating deposited at 50°C, peak current density of 25 A/dm<sup>2</sup>, and a duty cycle of 62.5% compared to (b) non-cracked DC coating deposited at 70°C and 30 A/dm<sup>2</sup>.

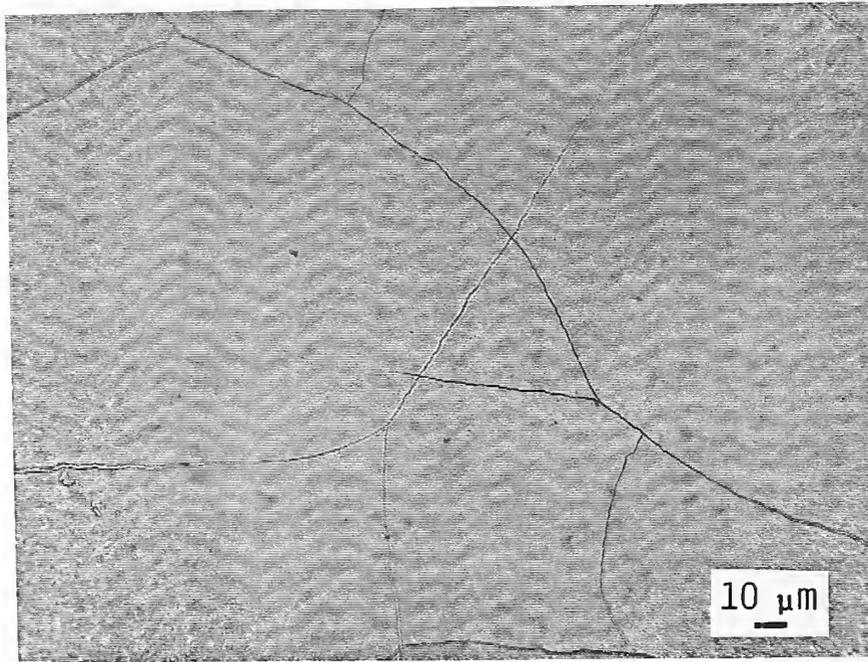
Figure 29. Optical micrograph of the surface texture and crack density of bright pulse plated chromium deposited at 50°C, peak current density of 25 A/dm<sup>2</sup>, and a duty cycle of 71.4%.

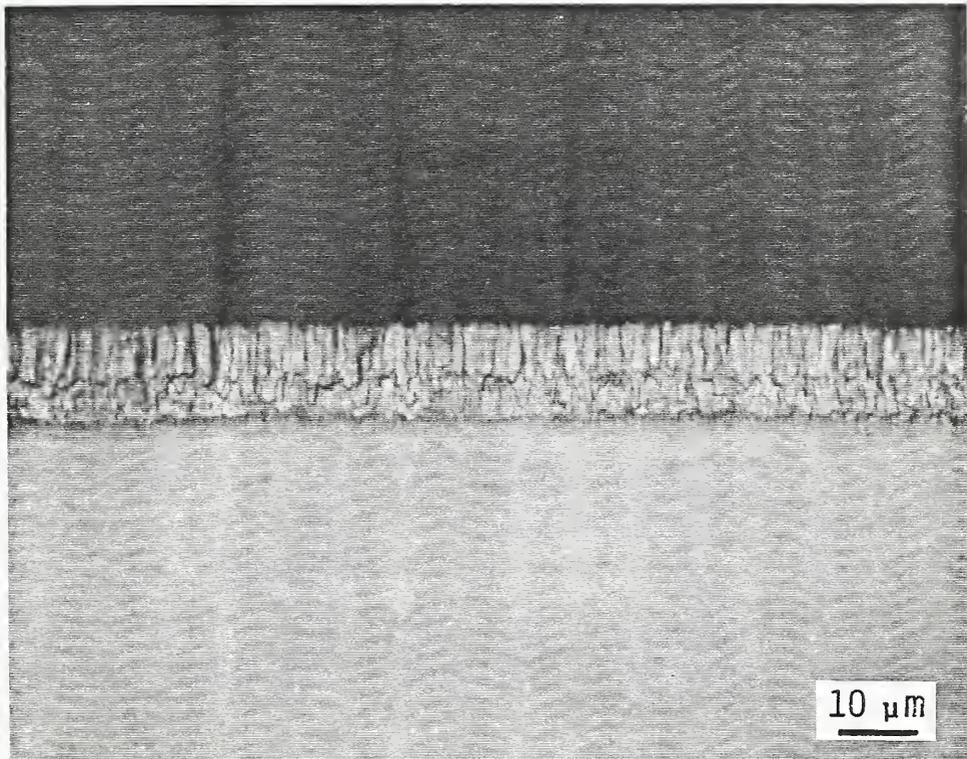
Figure 30. Optical micrograph of a sectioned pulse plated duplex chromium deposit etched in a 1:1 hydrochloric-lactic acid solution for 10 sec. The coating was deposited at 50°C and a peak current density of 25 A/dm<sup>2</sup>. The initial layer was deposited while pulsing at 5 ms on and 3 ms off (62.5% duty cycle) and the final layer at 5 ms on and 2 ms off (71.4% duty cycle).

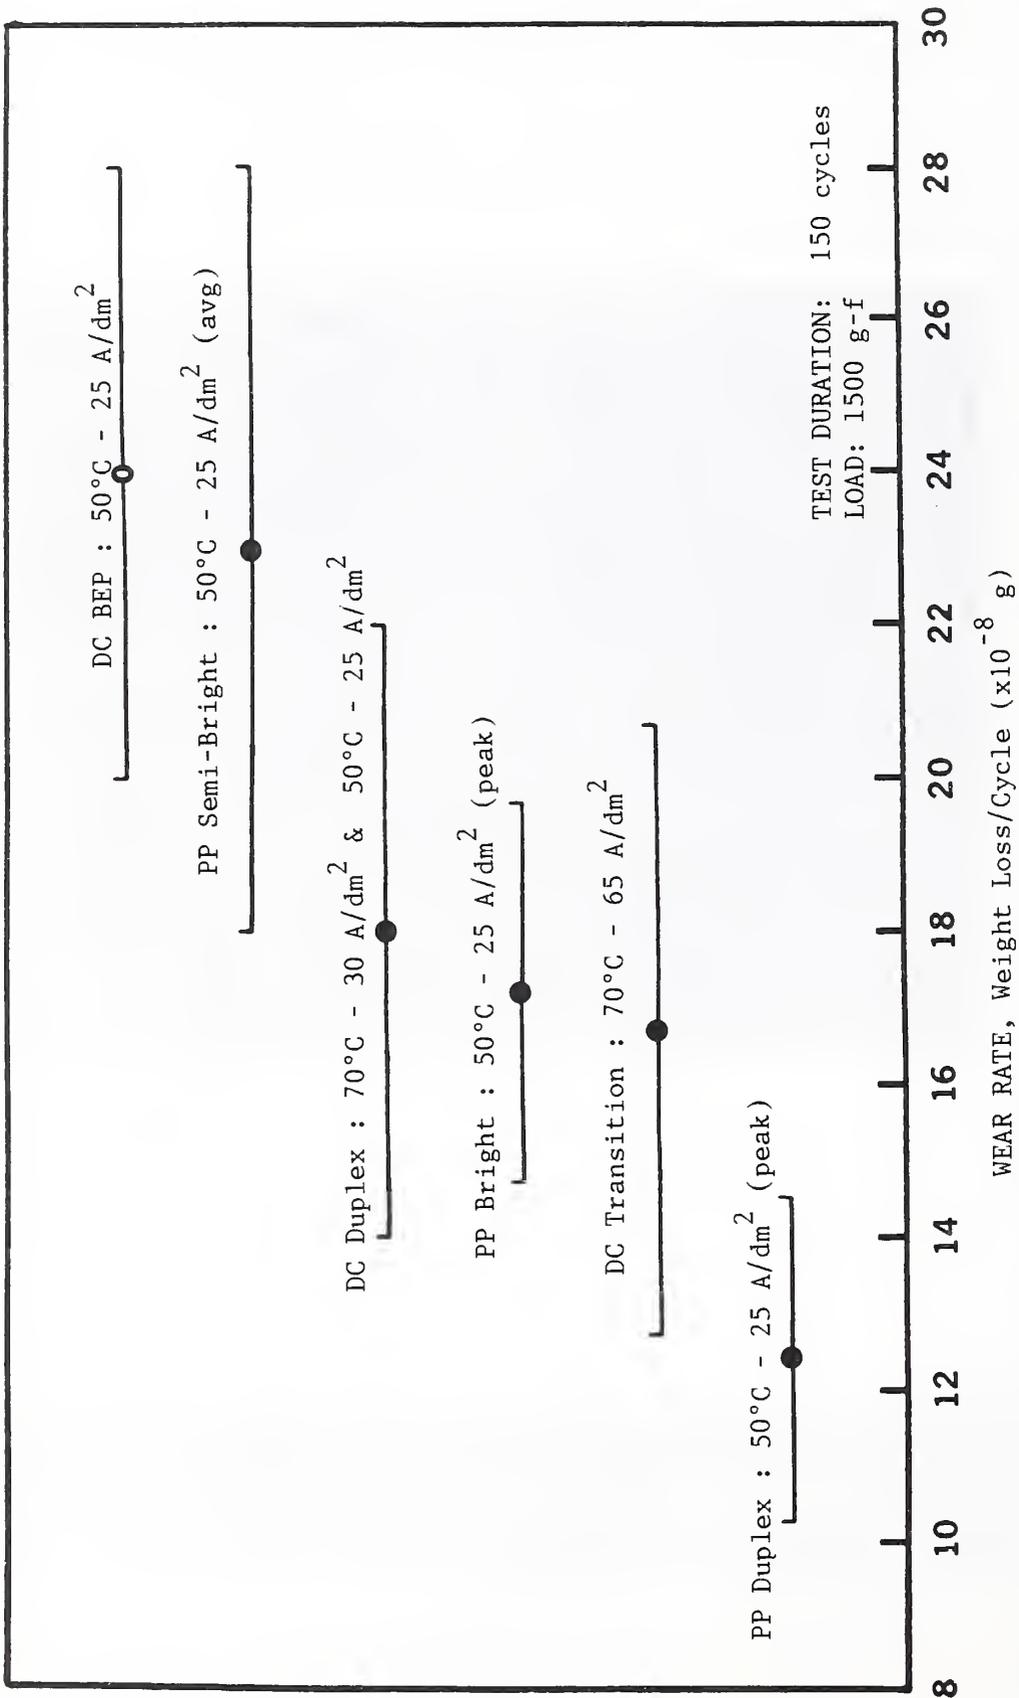
Figure 31. Wear rate determined by the abrasive slurry tester of pulse plated bright, semi-bright, and duplex chromium coatings compared to DC chromium coatings. Results are the average of five measurements plus and minus one standard deviation.

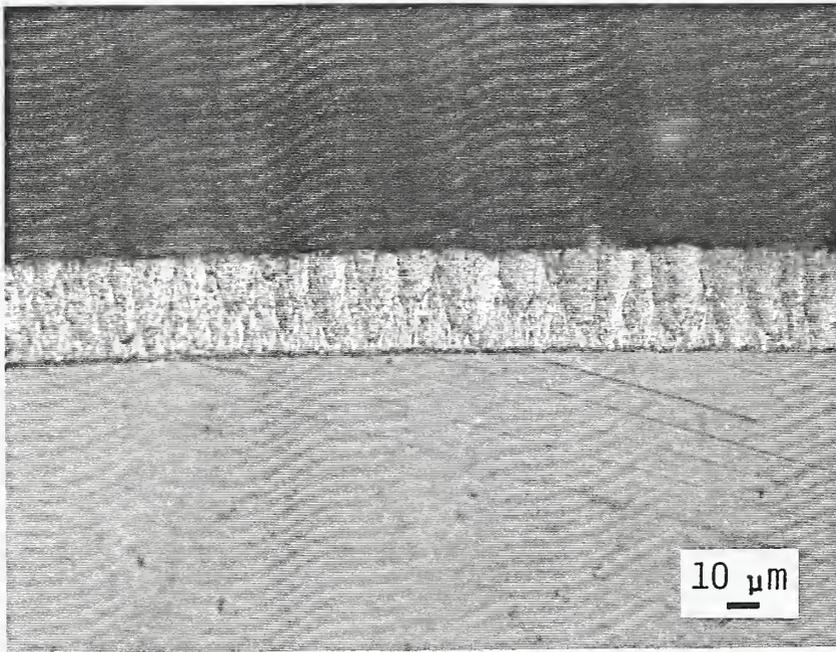
Figure 32. Optical micrograph of a polished and etched section of a pulse plated duplex chromium coating directly on a 52100 steel substrate. Note the superimposed columnar structure on the duplex structure. The columnar structure was not noted when plating on nickel.

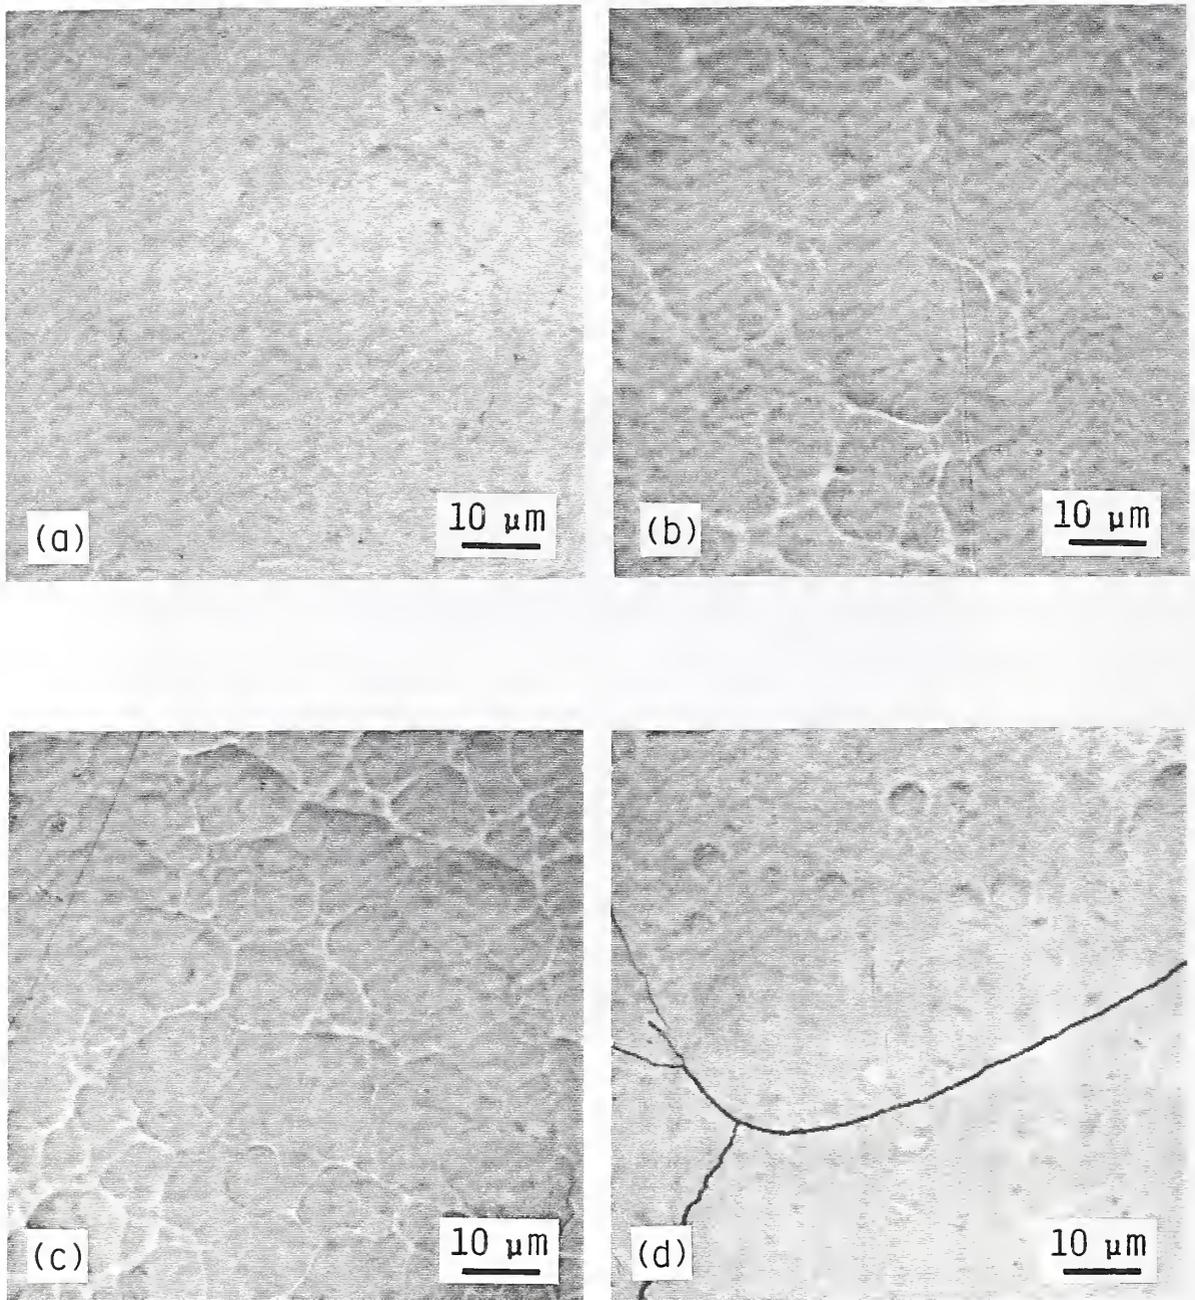
Figure 33. Optical micrographs of the surface texture and crack density of various DC and pulse plated chromium-vanadium deposits from a conventional sulfate catalyzed electrolyte containing 6.6 g/l  $V_2O_5$ . (a) DC - 50°C, 16 A/dm<sup>2</sup>. (b) DC - 50°C, 21.5 A/dm<sup>2</sup>. (c) DC - 50°C, 32 A/dm<sup>2</sup>. (d) PP - 50°C, 25 A/dm<sup>2</sup> (avg) at 10.5 ms on and 1.0 ms off.

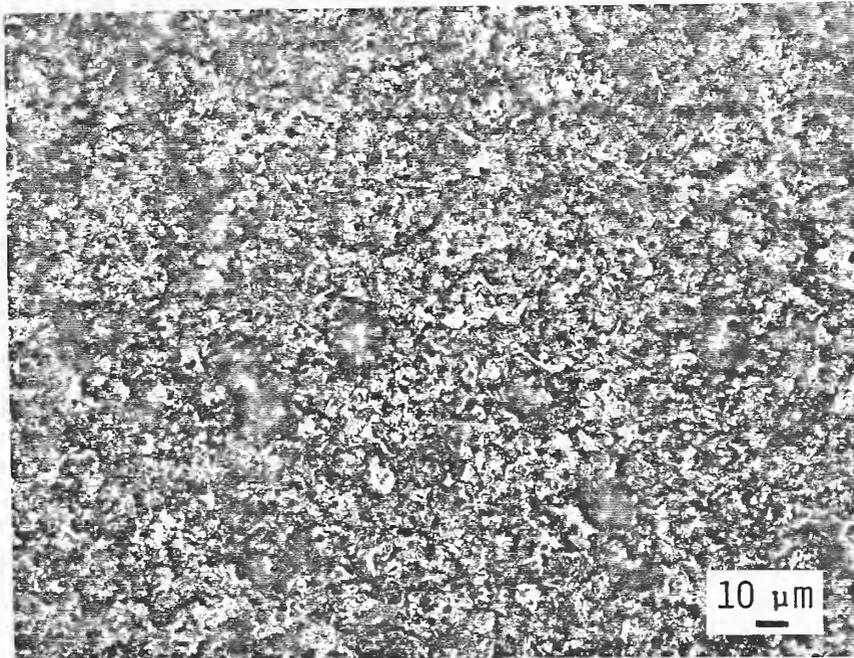
Figure 34. Optical micrograph of the surface of an electroless nickel-phosphorus-silicon carbide coating on a 52100 steel substrate.

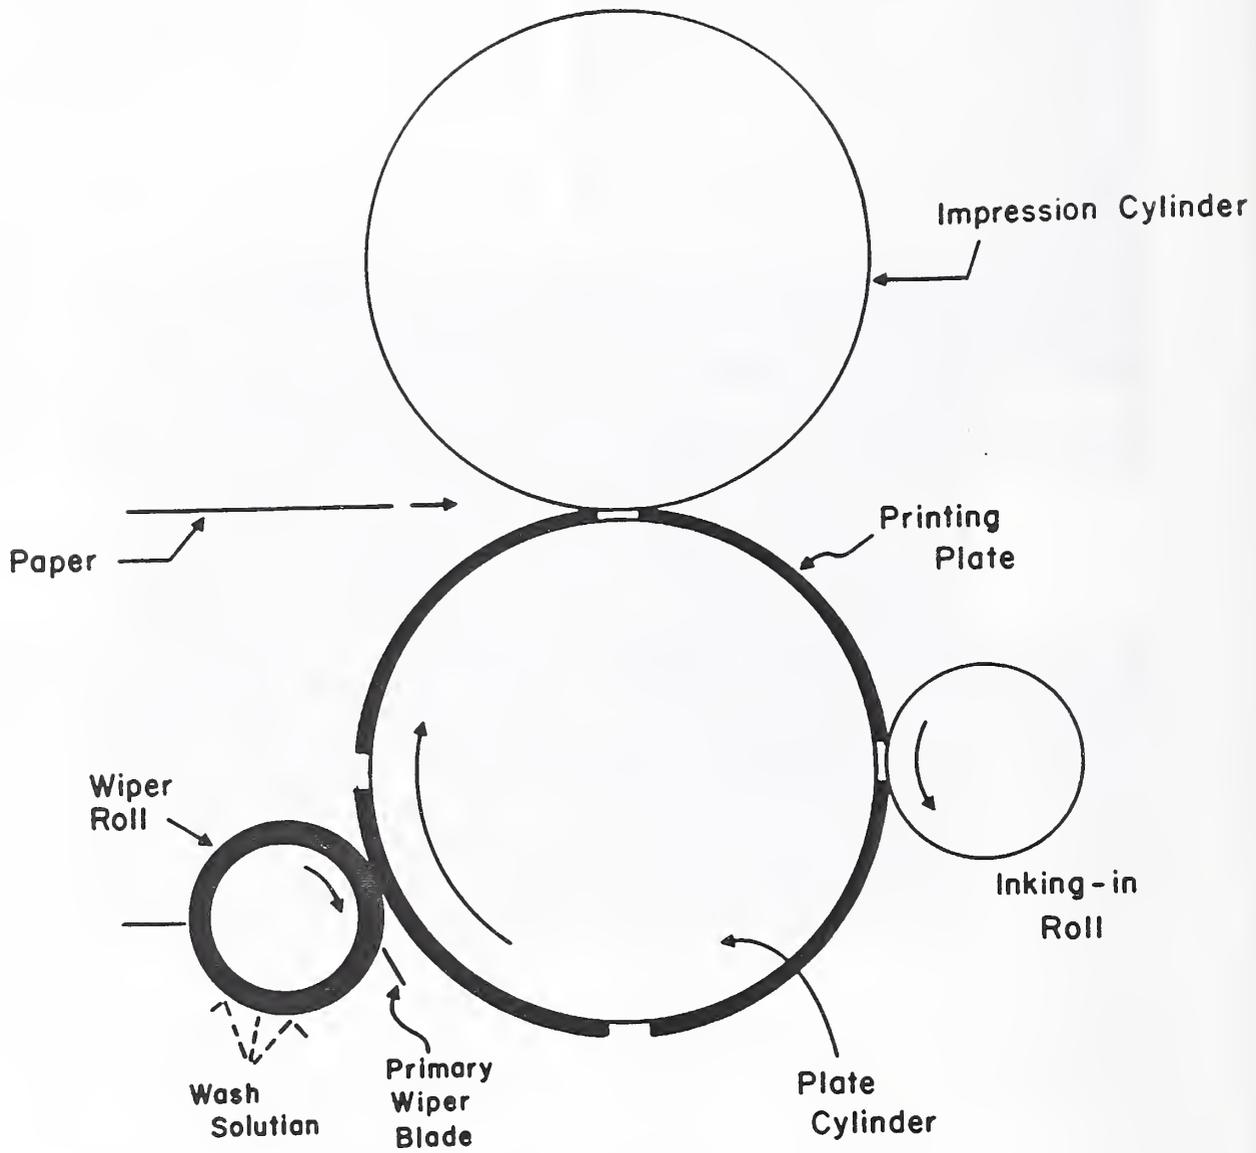
Figure 35. Schematic of printing press showing location of the primary wiper blade used for coatings evaluation in the in situ wear test.

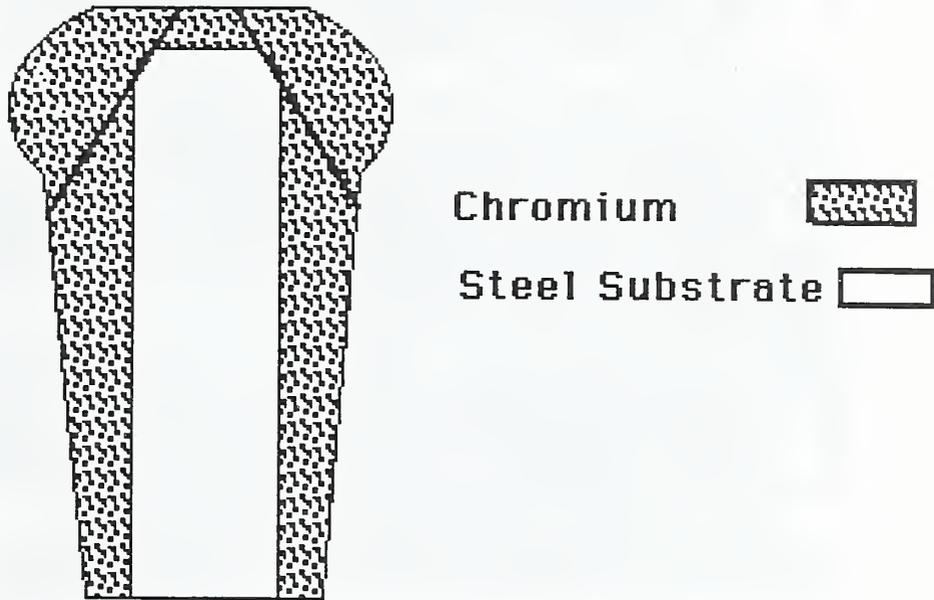
Figure 36. Schematic representation of a sectioned chromium plated wiper blade indicating the build-up (dog bone effect) of chromium on the edge of the blade and the wear scar path (solid angled lines) after in situ testing.

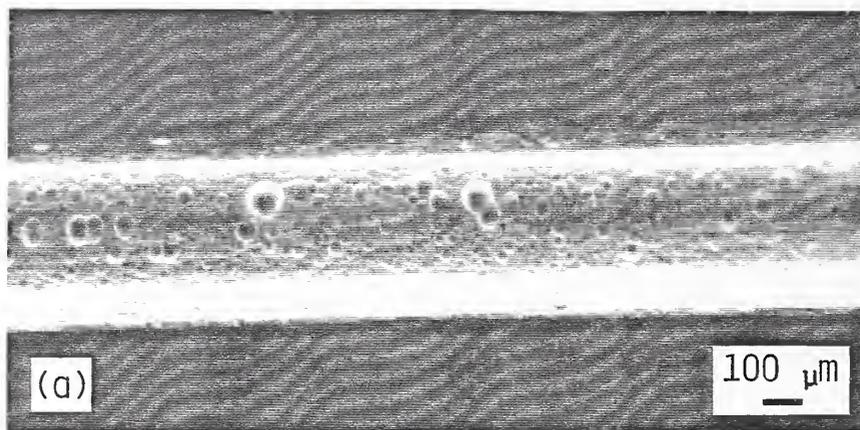
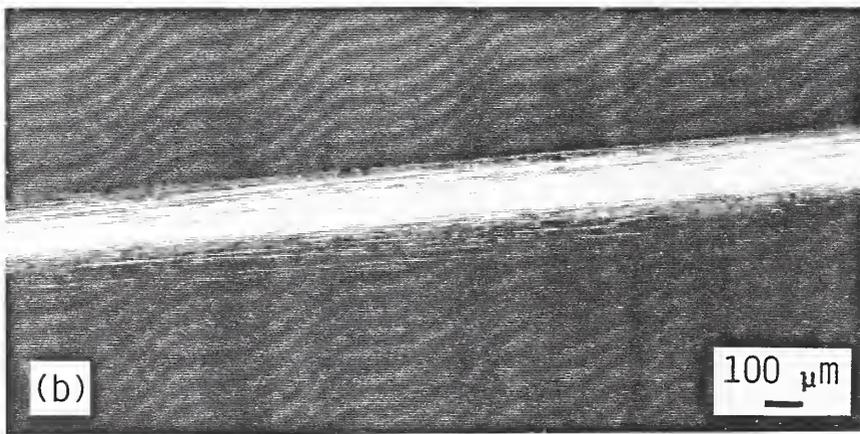
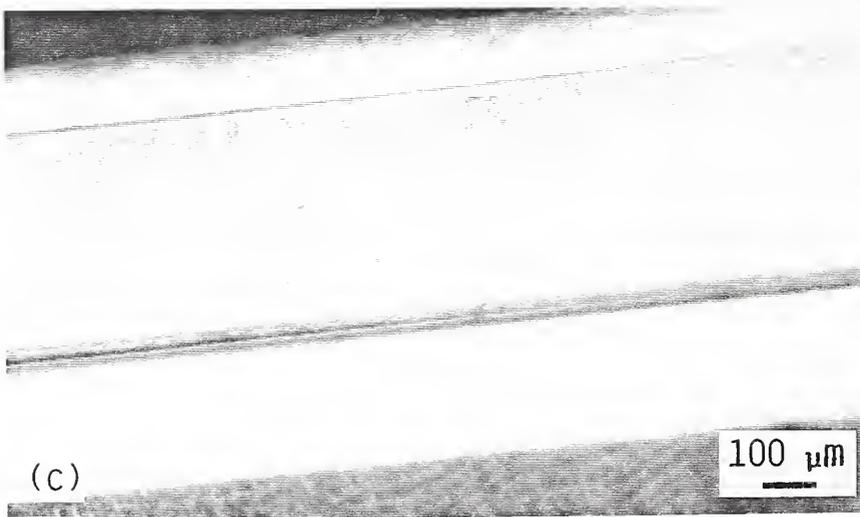
Figure 37. Optical photomicrographs of primary wiper<sub>2</sub> blade #50230-1 plated with BEP chromium at 50°C and 25 A/dm<sup>2</sup> (230 A/ft<sup>2</sup>). Blade was run to failure on one side (706, 345 impressions, 16 shifts). (a) As plated chromium on blade edge; (b) Worn chromium plated edge; (c) Wear scar area on side of chromium plated edge.

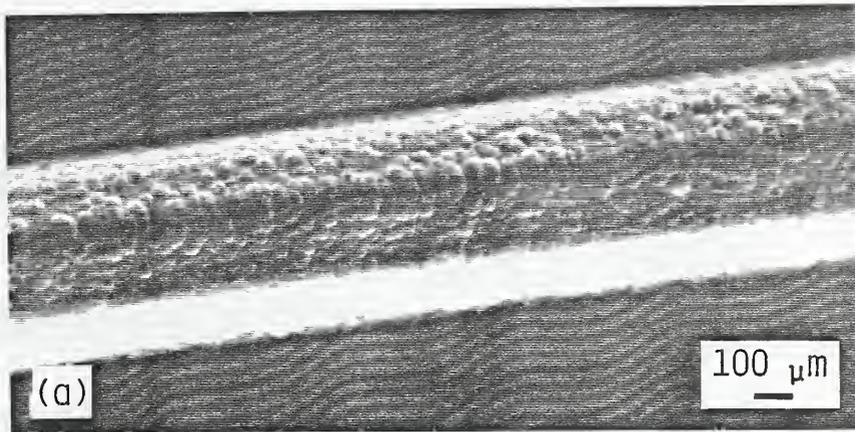
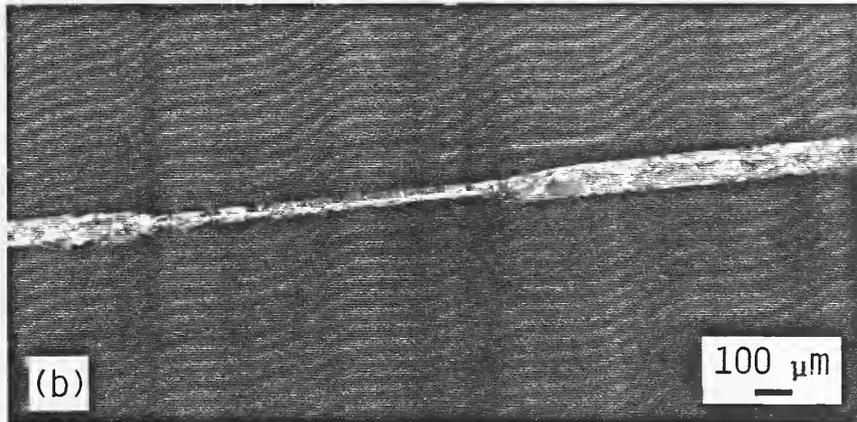
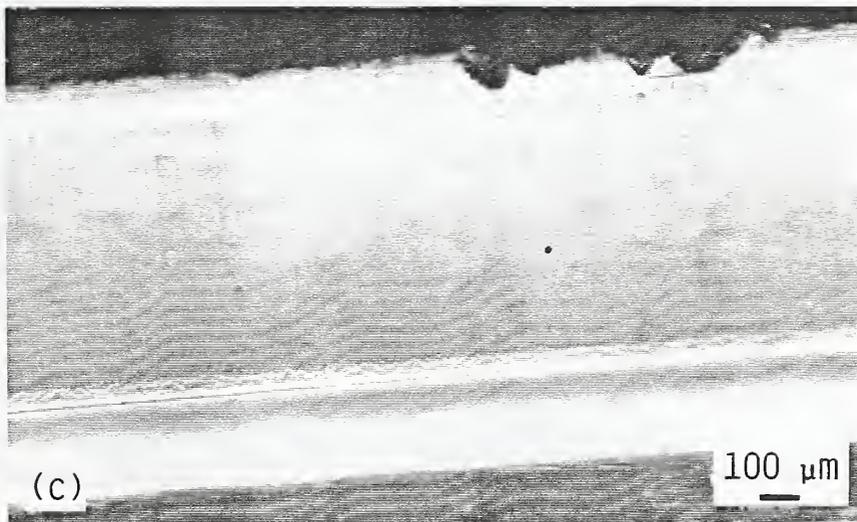
Figure 38. Optical photomicrographs of primary wiper blade #50230-2 plated with BEP chromium at 50°C and 25 A/dm<sup>2</sup> (230 A/ft<sup>2</sup>). Both sides of chromium plated edge were tested for a combined 1,113,400 impressions (26 shifts). (a) As plated chromium on blade edge; (b) Worn chromium plated edge; (c) Wear scar area on side of chromium plated edge.

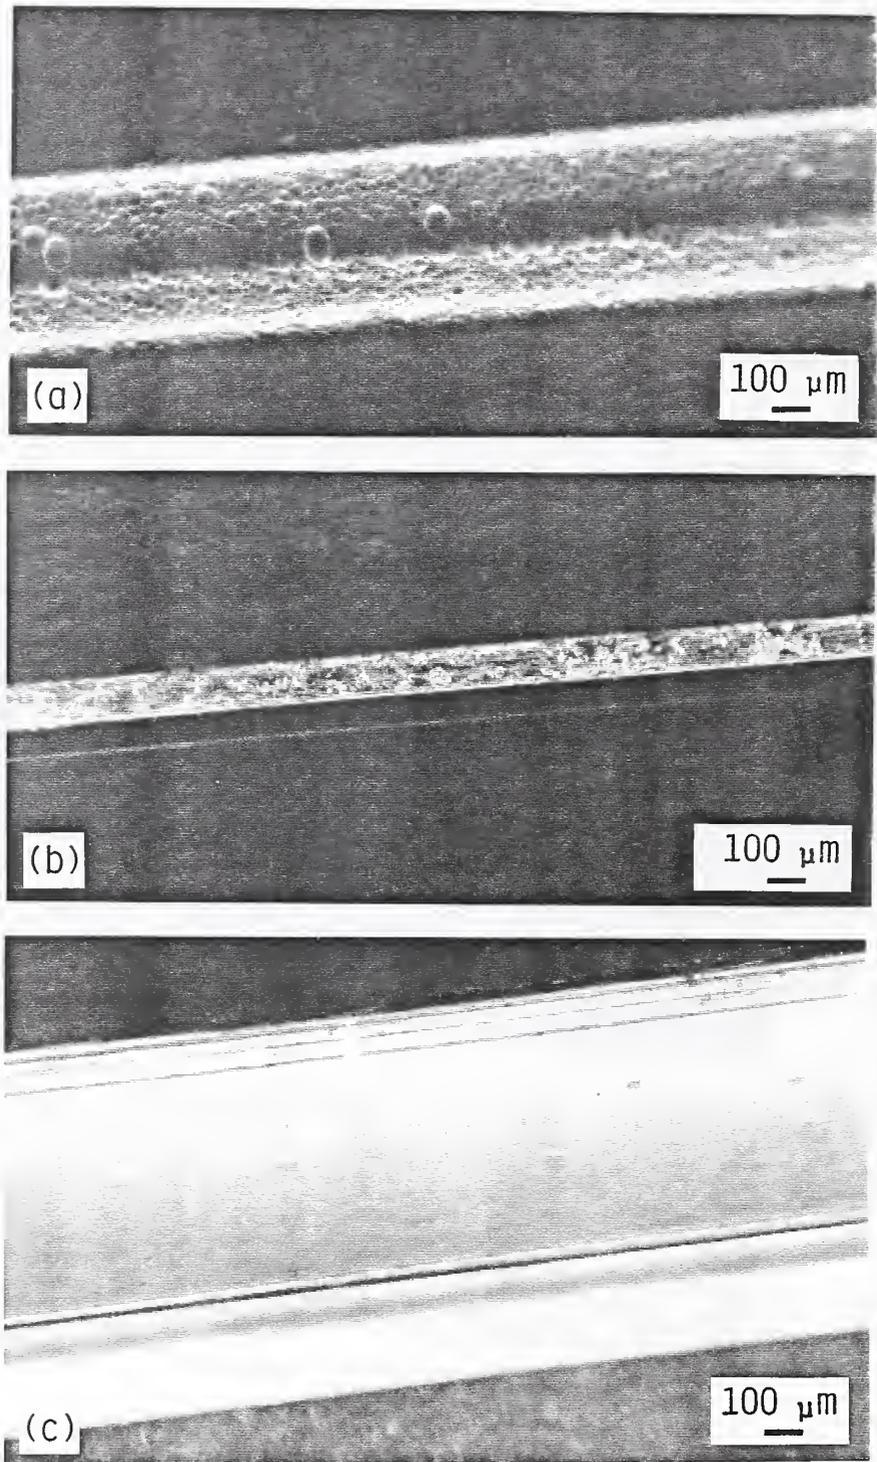
Figure 39. Optical photomicrographs of primary wiper<sub>2</sub> blade #50230-3 plated with BEP chromium at 50°C and 25 A/dm<sup>2</sup> (230 A/ft<sup>2</sup>). Both sides of chromium plated edge were tested for a combined 800,093 impressions (20 shifts). (a) As plated chromium on blade edge; (b) Worn chromium plated edge; (c) Wear scar area on side of chromium plated edge.

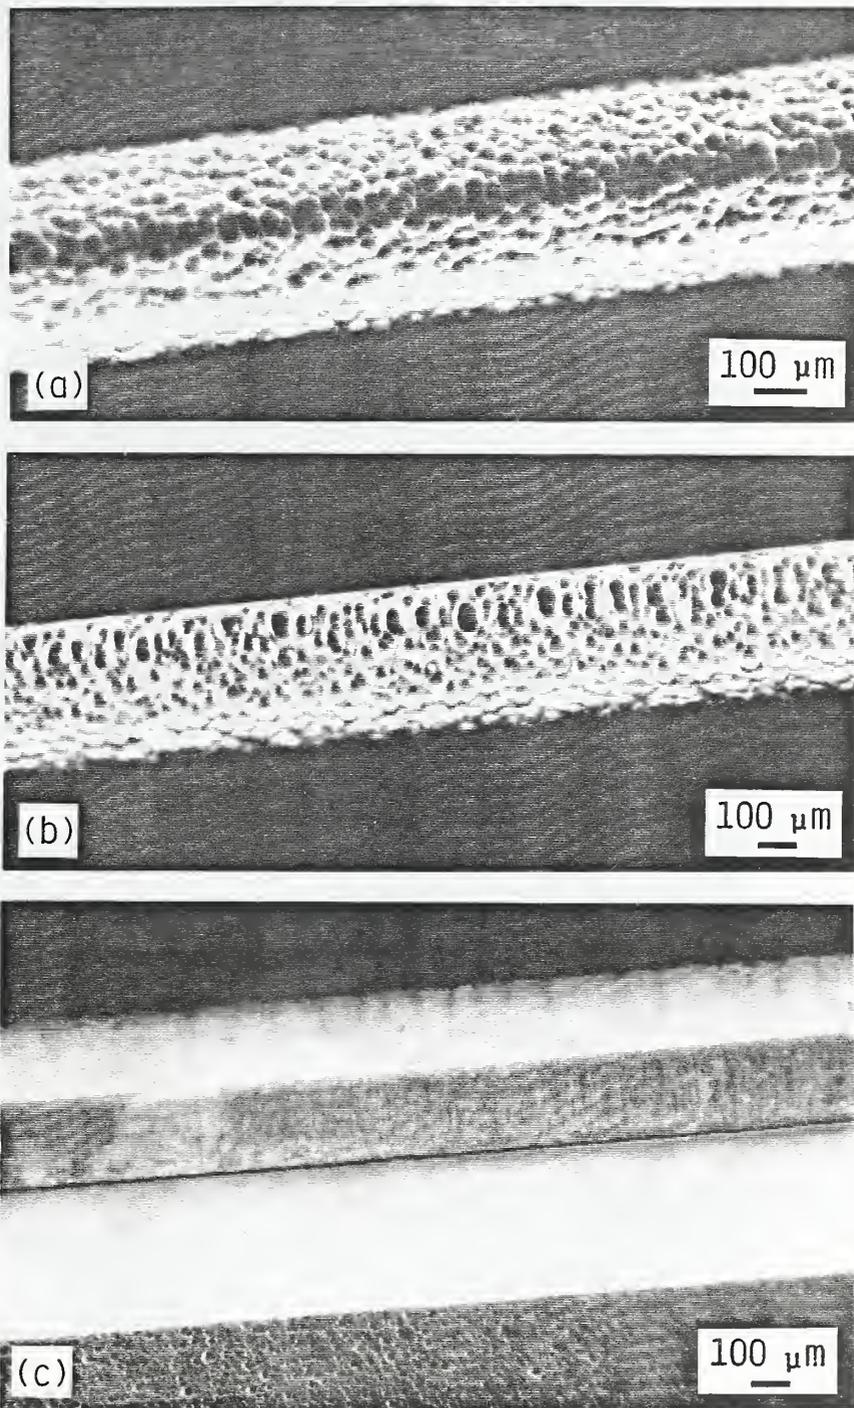
Figure 40. Optical photomicrographs of primary wiper<sub>2</sub> blade #50230-4 plated with BEP chromium at 50°C and 25 A/dm<sup>2</sup> (230 A/ft<sup>2</sup>). Only one side of chromium plated edge was tested. (a) As plated chromium on blade edge; (b) Worn chromium plated edge; (c) Wear scar area on side of chromium plated edge.
